Test Report

No. SZXEC1800612201

The following sample(s) was/were submitted and identified on behalf of the clients as :
TLSMB75/CL32/WG100E(Y3)

Halogen

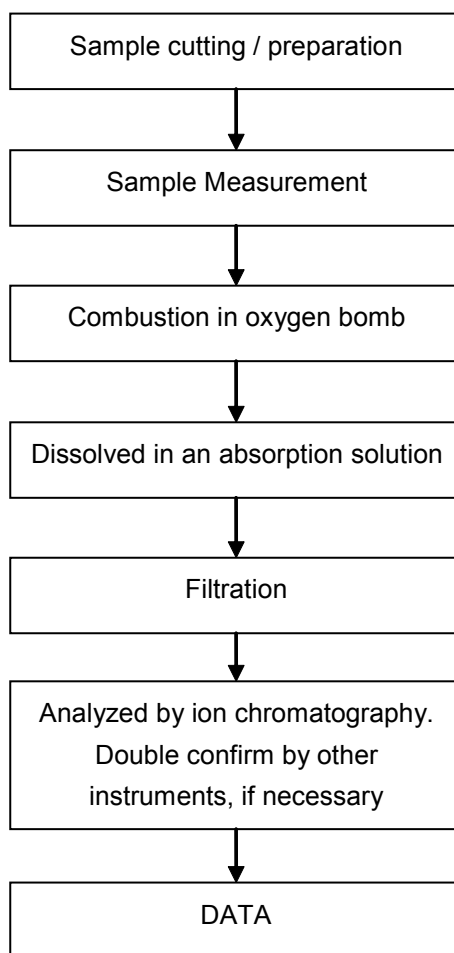
Halogen Testing Flow Chart

Test Method : With reference to EN 14582:2016, analysis was performed by Ion Chromatograph (IC).

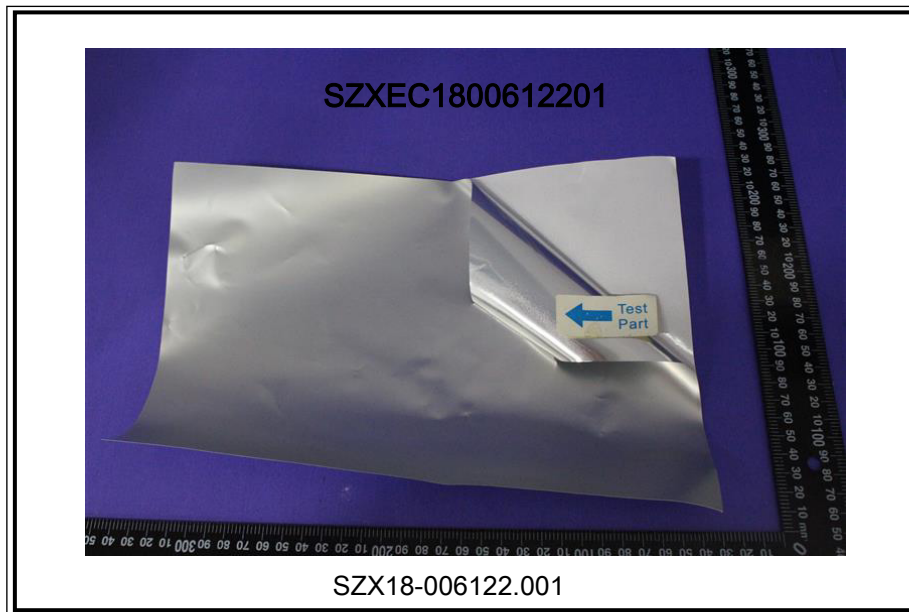
Sample photo:

Specimen No.	SGS Sample ID	Description
SN1	SZX18-006122.001	Gray adhesive sheet
